# The Arroyo Colorado Watershed Partnership Newsletter

Winter 2022

## Llano Grande Lake Restoration Preliminary Feasibility Project

## GIS-Based Model Assesses OSSF Contamination Risks

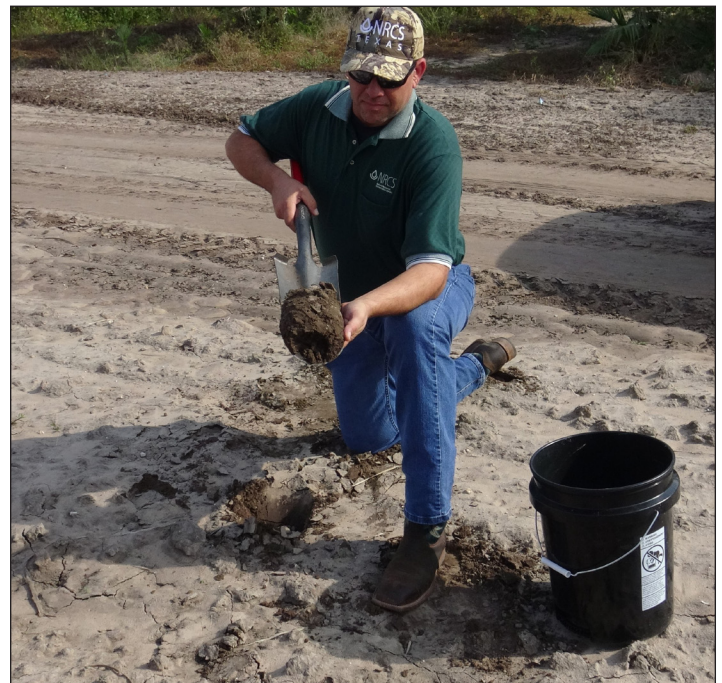
Gabriel Cavazos, Conservation Agronomist, USDA-NRCS Hidalgo Co., demonstrating how to collect a soil sample. Photo by Jaime Flores.

(continued from page 1) Instructions for soil sampling and sample bags can be picked up at the Hidalgo, Cameron, and Willacy County AgriLife Extension offices, the Texas State Soil and Water Conservation Board (TSSWCB) Harlingen regional office, or U.S. Department of Agriculture (USDA) service centers in those three counties. Once soil samples are collected, they can be dropped off at those same locations for shipping to the Soil, Water and Forage Testing Laboratory at Texas A&M University in College Station.

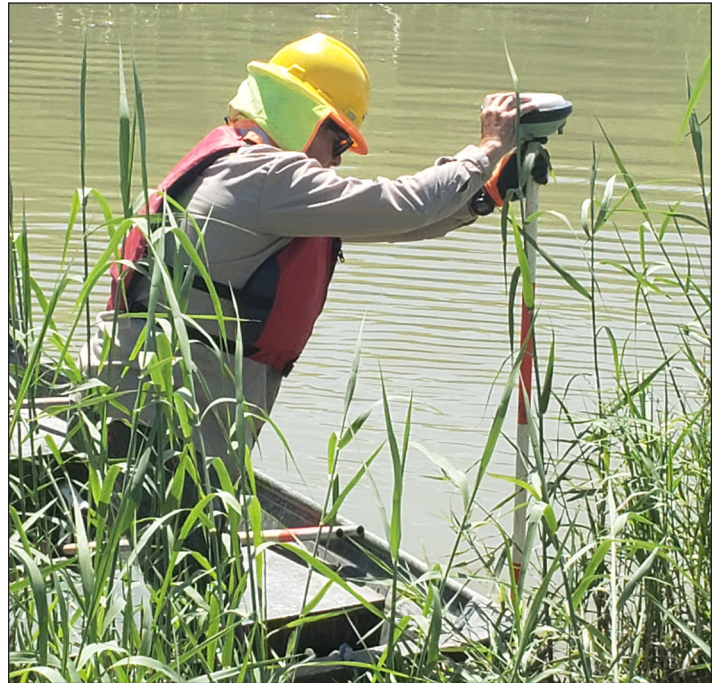
Measuring sediment thickness in Llano Grande Lake. Photo by Jaime Flores.

In September 2020, Ambiotec Civil Engineering Group, Inc. conducted a bathymetric survey of the lake in coordination with TWRI. Based on depth-to-sediment data collected at four lake cross sections, it was found that between five and 12 feet of sediment accumulation exists in the lake. Water depths recorded ranged from less than one to only 4 feet in measured areas. Based on these findings, it is estimated that approximately 1.4 million cubic yards of sediment has accumulated in the lake. This equates to roughly 282.7 million gallons of stormwater capacity that is currently unavailable.
