Lower Laguna Madre/ Brownsville Ship Channel Watershed Characterization 2018

Prepared by:

University of Texas –Rio Grande Valley, Brownsville

TCEQ Contract 582-14-41167

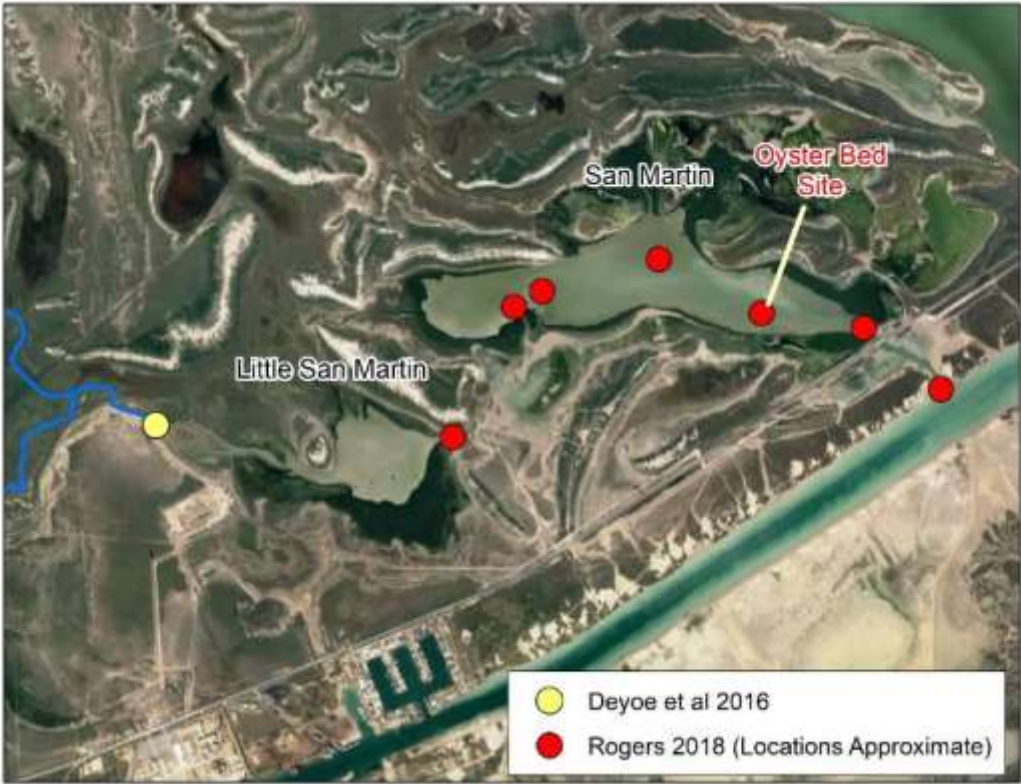
Figure 4-13: San Martin Lake system sampling sites from previous research (DeYoe et al 2016) (Rogers 2018)

DeYoe et al., (2016) conducted 24-hour flow monitoring and nutrient sampling at a site upstream of Little San Martin Lake (Figure 4-13). This study was designed to estimate nutrient loading contributions from four ungaged subwatersheds in south Texas including San Martin Lake subwatershed. Sampling was done from June 2014 to November 2015. Results from the San Martin Lake site (POB north) for the period June 18 – 22 in 2014 are presented here. Daily tidal influence is observed for approximately 6 hours each day (Figure 4-14). Nutrient sampling over a portion of this period also shows higher nitrate concentrations and daily fluctuations than ammonia and phosphate during the same period (Figure 4-16). One notable feature of a November 2014 sample date for this site was that organic nitrogen made up a significant % of the total nitrogen ranging from 4 to 97% with an average of 34.2%.

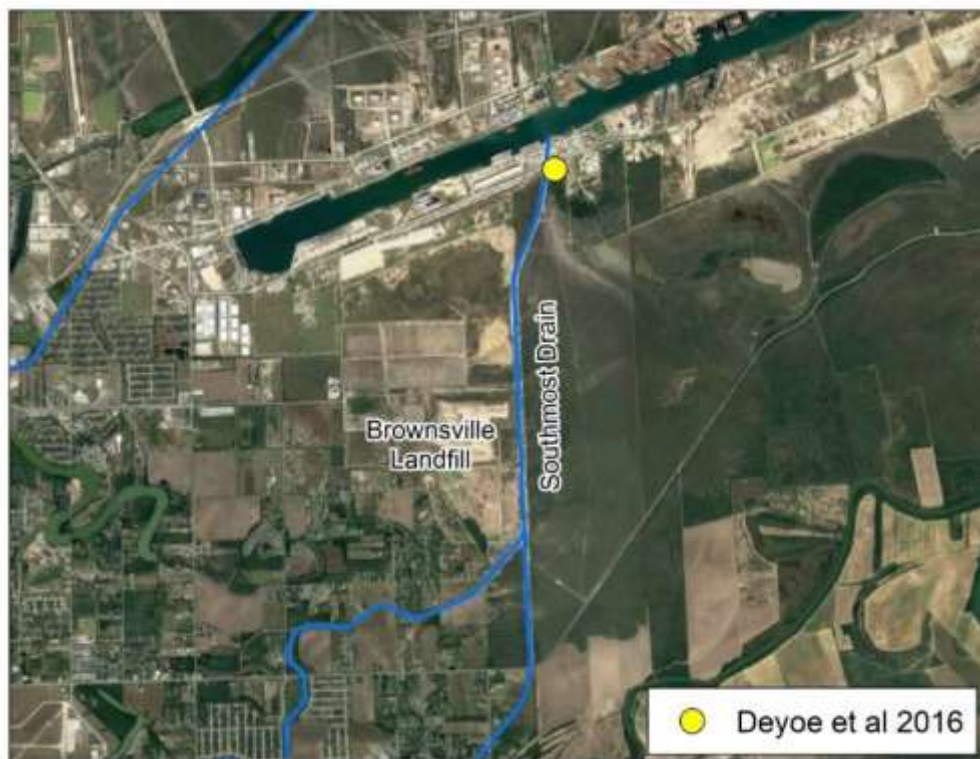
Figure 4-26: Southmost Drain sampling site in Brownsville subwatershed (DeYoe et al 2016)

There is limited data for the Southmost drain. DeYoe et al., (2016) conducted 24-hour flow monitoring and nutrient sampling at a site on the Southmost Drain about 200 m upstream of its outlet into the Brownsville Ship Channel (Figure 4-26). Data was captured for a rainfall event (4.11in.) from September 12-14, 2014. Salinity, dissolved phosphate, nitrate-nitrite, and ammonia samples were collected each hour for 24-hours (Figure 4-27). For the first hour, salinity was about 35ppt and then decreased below 5ppt by hour 3 and remained below 5ppt for the remainder of the sampling. Nitrate-nitrite concentrations increased significantly from hours 5-18 of the event and then declined to background levels. Low salinity during sampling (below 5ppt) indicates that much of the stormwater reached the Ship Channel outfall. High salinity during the first 2 hours of sampling indicates that the initiation of the runoff event was captured. Another rainfall event of 1.7in from August 30 – September 1, 2014 was sampled and flow was measured over a 48-hour period (Figure 4-28). The flow was measured close to 0 at the beginning of the event showing likely tidal influence and then peaked at greater than 4,000m³/hr. It is important to note that throughout the 48 hours it appears that there was always flow towards Ship Channel even during high tides. This indicates that the Southmost Drain may contribute more freshwater to Ship Channel than San Martin Lake. Further research is needed to confirm this.
