Pollution Issues in the Lower Laguna Madre Related to the Arroyo Colorado

Thomas Whelan III
Associate Professor
Chemistry Department
UTPA

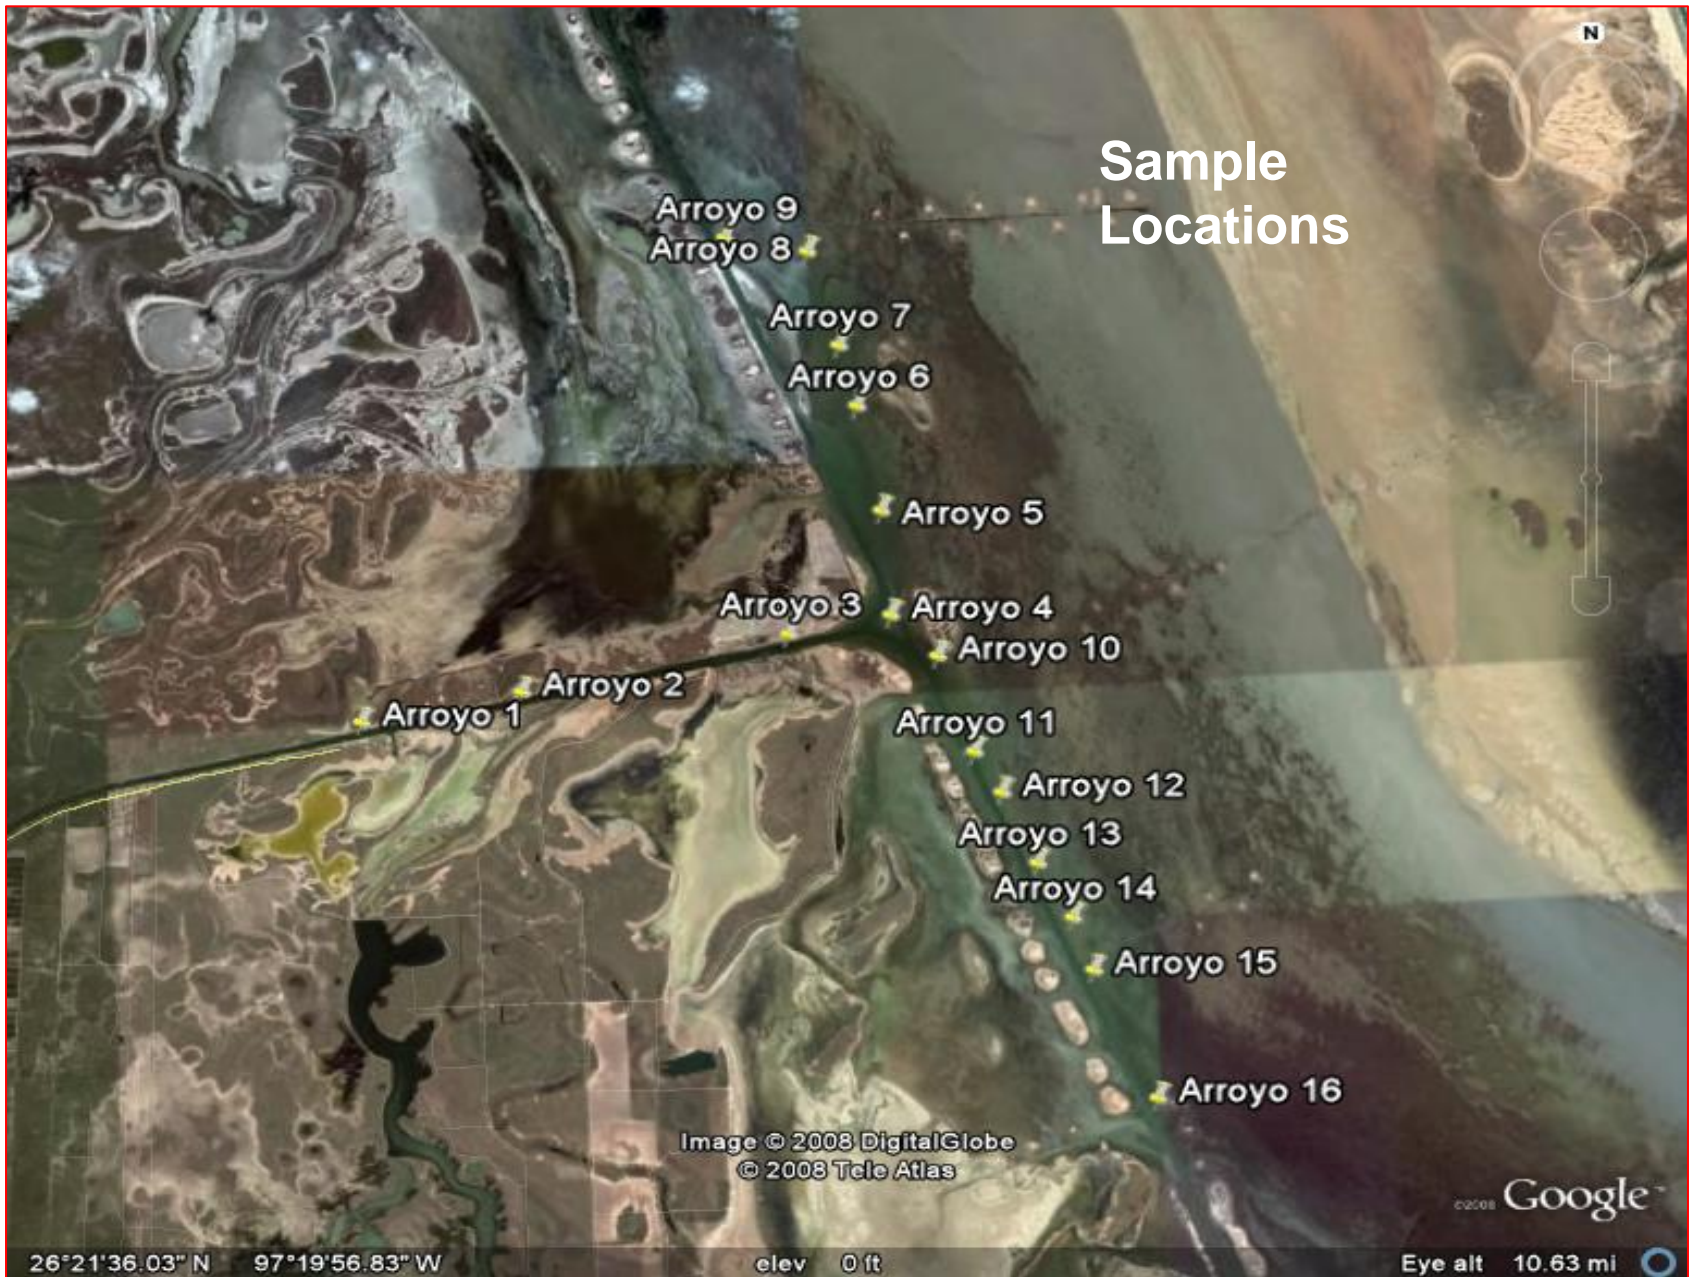
Arsenic in Arroyo/LLM

Possible indicator of extent of inorganic contamination

If arsenic is present, other pollutants are likely present

Toxic levels may not be present in water but could be accumulated in seagrass resulting in death
